Progress Report Façade Restoration Church of the Blessed Sacrament September 2018

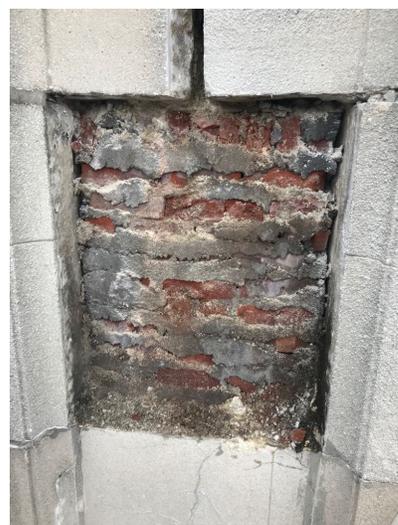
Cast stone removal with exposed brick substrate. The damaged stone will be re-fabricated and replaced.

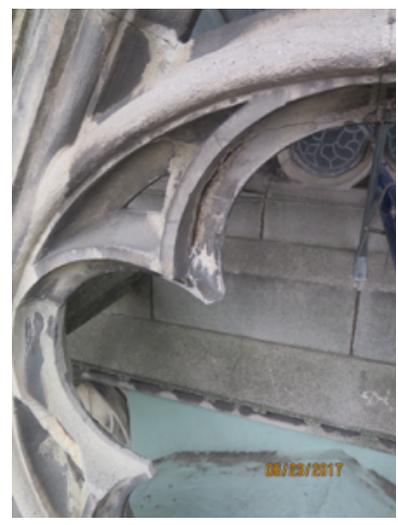
Deteriorated free standing Pentafoil pediment cast stones.

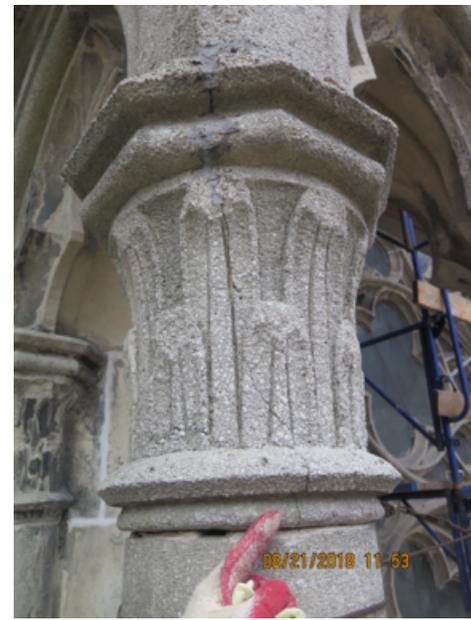
Hairline crack in the column capital of the sculptural niche. Temporary shoring will need to be installed to extract and replace the cracked column capital while leaving the rest of the structure in place.
